# TEST REPORT

Name (Type)	SF72	Rim Size	17X8JJ
Offset(mm)	30	P.C.D	120 mm
Number of bolt(holes)	5	Structure	One piece
Material	AL	Manufacturing method	Casting

Manufacturer : **Beyern Multi** (stamp)

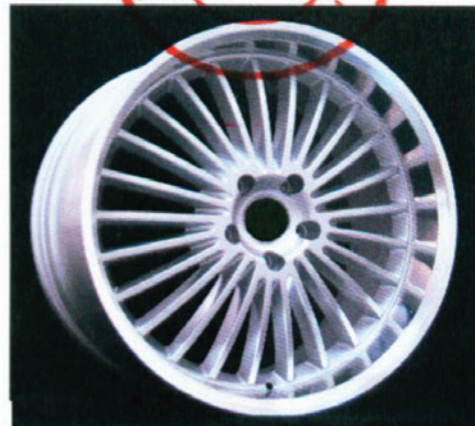
Name (Type)	SF72	Rim Size	17X8, 0J
Offset(mm)	40	P.C.D	120 mm
Number of bolt(holes)	5	Structure	One piece
Material	AL	Manufacturing method	Casting

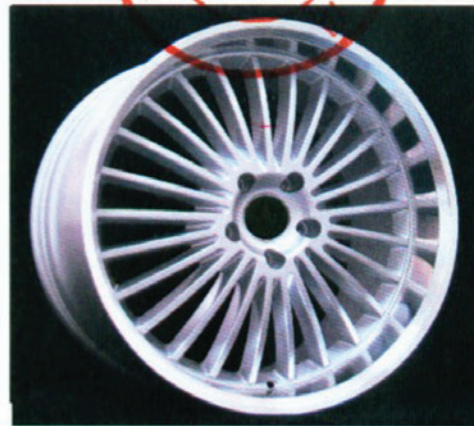
Name (Type)	SF72	Rim Size	18X8. 5J
Offset(mm)	40	P.C.D	120 mm
Number of bolt(holes)	5	Structure	One piece
Material	AL	Manufacturing method	Casting

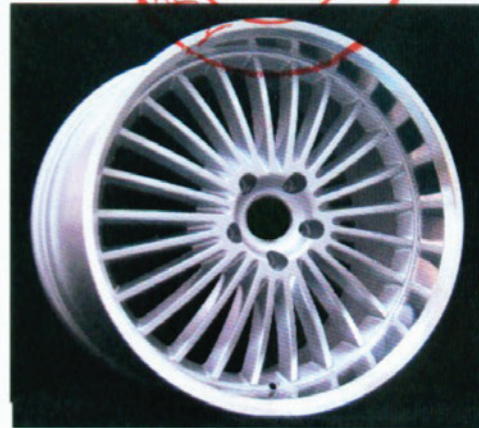
Name (Type)	SF72	Rim Size	18X9.5J
Offset(mm)	45	P.C.D	120 mm
Number of bolt(holes)	5	Structure	One piece
Material	AL	Manufacturing method	Casting

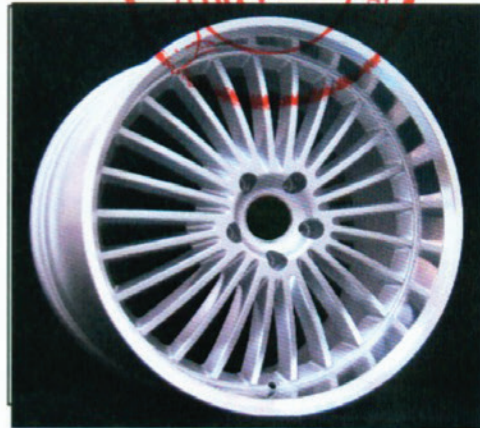
Name (Type)	SF72	Rim Size	19X8.5J
Offset(mm)	40	P.C.D	120 mm
Number of bolt(holes)	5	Structure	One piece
Material	AL	Manufacturing method	Casting

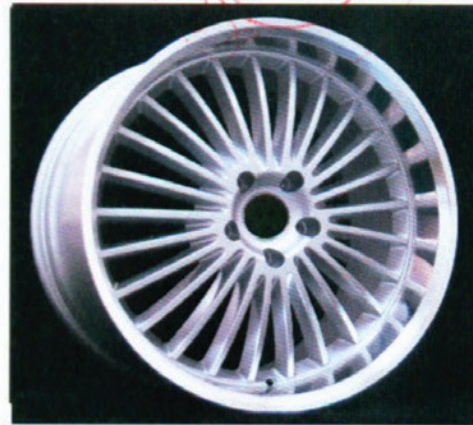
Name (Type)	SF72	Rim Size	19X9.5J
Offset(mm)	45	P.C.D	120 mm
Number of bolt(holes)	5	Structure	One piece
Material	AL	Manufacturing method	Casting

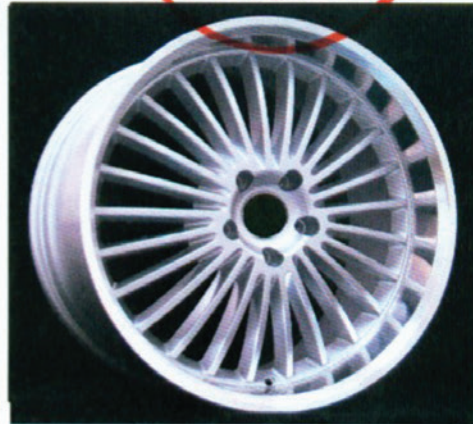
Name (Type)	SF72	Rim Size	20X10J
Offset(mm)	40	P.C.D	120 mm
Number of bolt(holes)	5	Structure	One piece
Material	AL	Manufacturing method	Casting

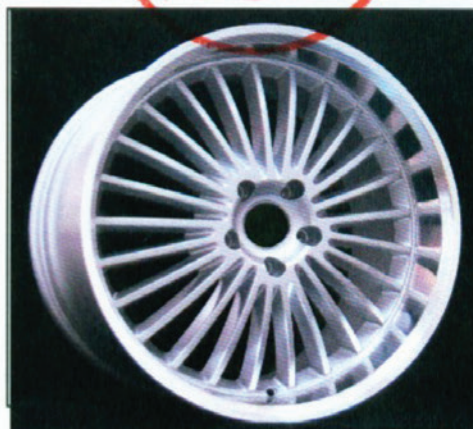
Name (Type)	SF72	Rim Size	20X8. 5J
Offset(mm)	40	P.C.D	120 mm
Number of bolt(holes)	5	Structure	One piece
Material	AL	Manufacturing method	Casting

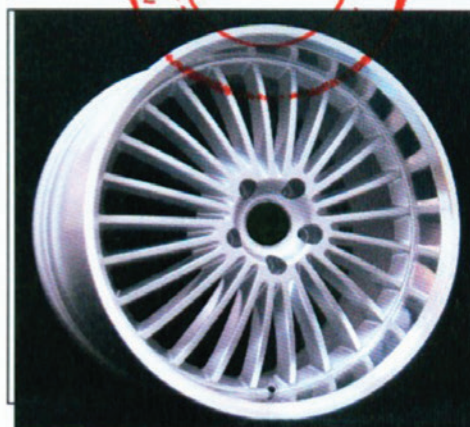
Name (Type)	SF72	Rim Size	22X11J
Offset(mm)	25	P.C.D	120 mm
Number of bolt(holes)	5	Structure	One piece
Material	AL	Manufacturing method	Casting

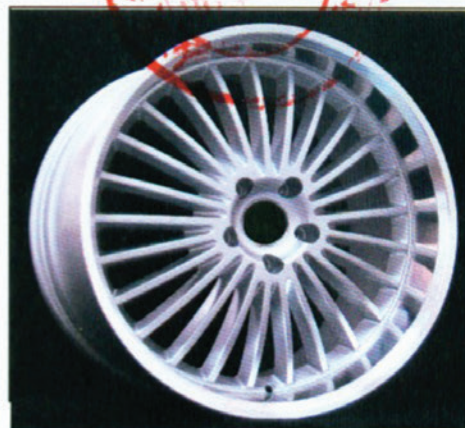
Name (Type)	SF72	Rim Size	22X9.5J
Offset(mm)	35	P.C.D	120 mm
Number of bolt(holes)	5	Structure	One piece
Material	AL	Manufacturing method	Casting
